Dry operating, single plate cable operated clutch.

### Exploded view

B.V. JB

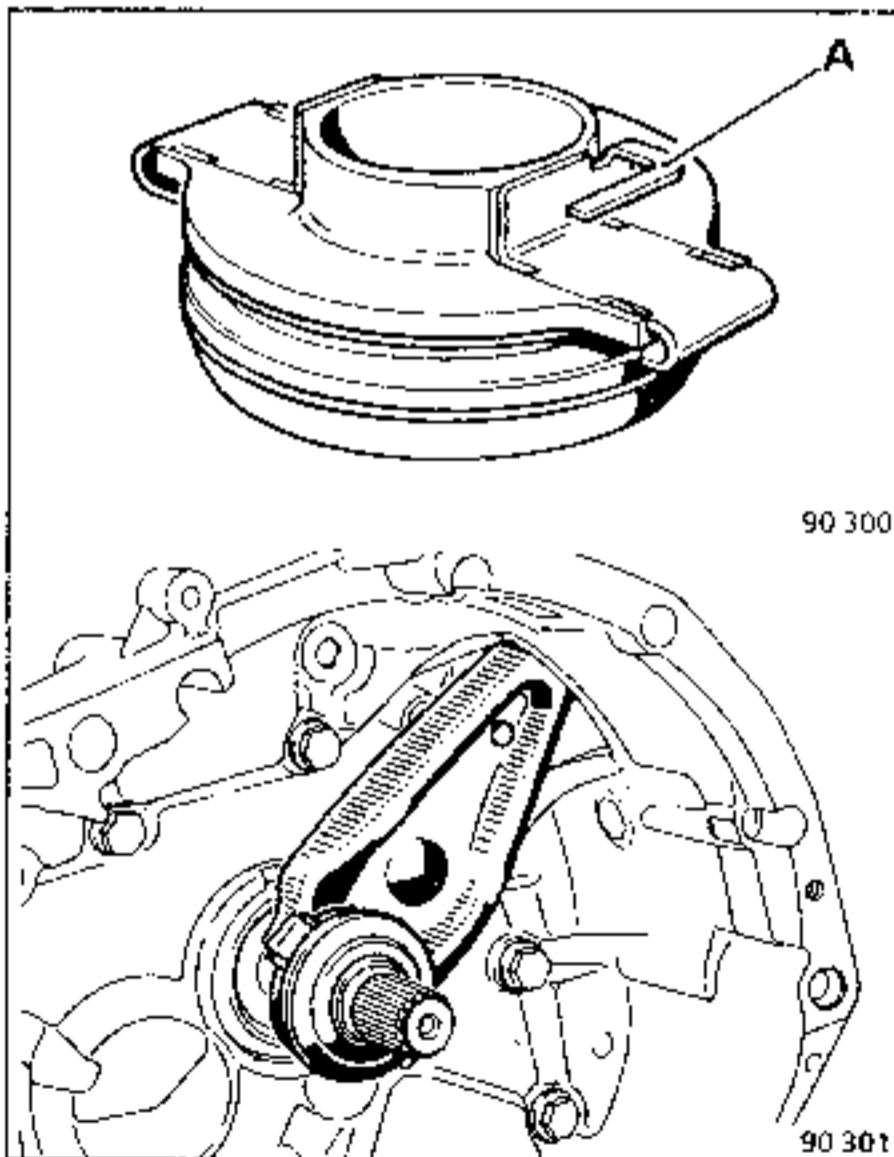
Fit the guide tube on the thrust pad ensuring lug (A) is correctly located in the fork

Ensure the assembly slides correctly.

**NOTE :** after an operation which does not require the gear box to be removed or after fitting the gear box **DO NOT LIFT** the fork as it may be separated from the lug (A) on the thrust pad.
